Contract #: 04-0120F4Cty: SF/ALA Rte: 80 PM: 13.2/13.9File #: 69.28**WELDING INSPECTION REPORT****Resident Engineer:** Siegenthaler, Peter**Address:** 333 Burma Road**City:** Oakland, CA 94607**Report No:** WIR-017705**Date Inspected:** 02-Nov-2010**Project Name:** SAS Superstructure**OSM Arrival Time:** 700**Prime Contractor:** American Bridge/Fluor Enterprises, a JV**OSM Departure Time:** 1900**Contractor:** Zhenhua Port Machinery Company, Ltd (ZPMC), Changxing Island **Location:** Shanghai, China**CWI Name:** Liu Hua Jie**CWI Present:** Yes No**Inspected CWI report:** Yes No N/A**Rod Oven in Use:** Yes No N/A**Electrode to specification:** Yes No N/A**Weld Procedures Followed:** Yes No N/A**Qualified Welders:** Yes No N/A**Verified Joint Fit-up:** Yes No N/A**Approved Drawings:** Yes No N/A**Approved WPS:** Yes No N/A**Delayed / Cancelled:** Yes No N/A**Bridge No:** 34-0006**Component:** OBG Segments**Summary of Items Observed:**

On this date Caltrans OSM Quality Assurance (QA) Inspector, Dan Hernandez was present during the times noted above to observe the fit up, welding and related activities associated with the fabrication of the San Francisco Oakland Bay Self Anchored Susp

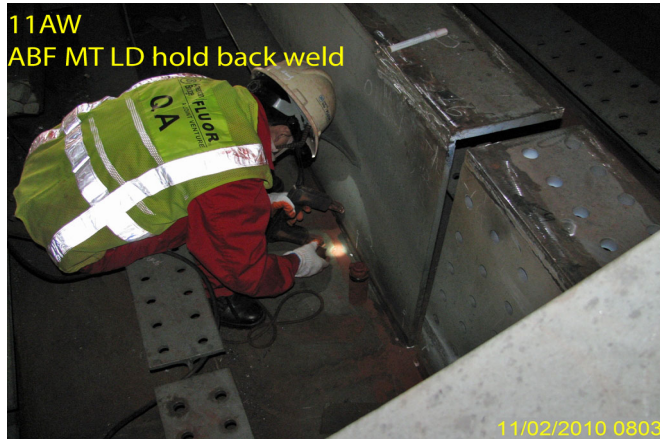
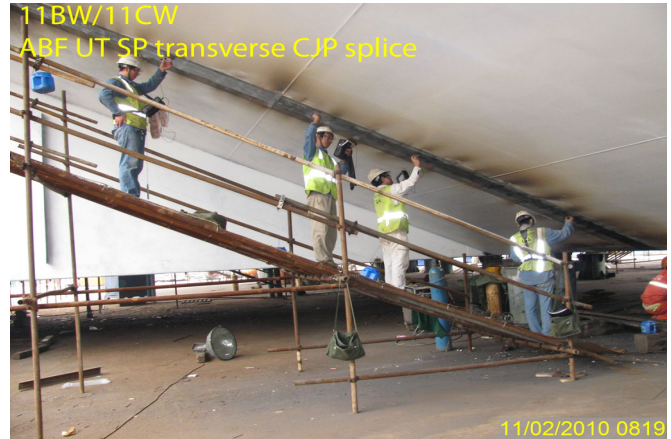
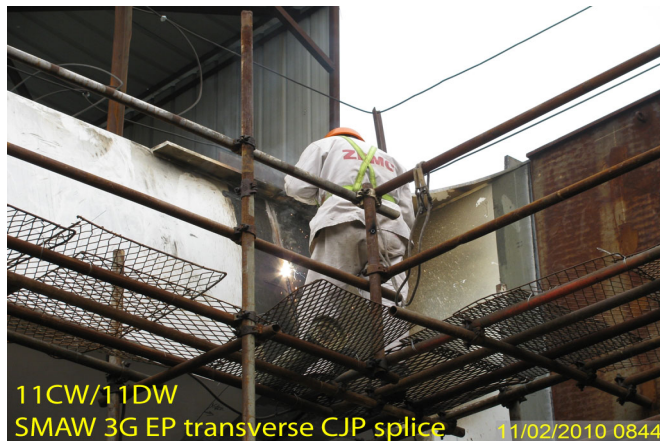
This QA Inspector observed Shielded Metal Arc Welding (SMAW) in progress of a Complete Joint Penetration (CJP) weld joint. The Weld joint is designated DP706-001-020, Deck Plate I-rib stiffener web Splice. The welder is identified as #500363 and was observed welding in the 3G (vertical) position using approved Welding Procedure Specification WPS-B-T-3213-B-U3b.

This QA Inspector observed Flux Cored Arc Welding (FCAW) in progress of a fillet weld joint. The Weld joint is designated SP170-001-004, Side Plate WT stiffener hold back weld. The welder is identified as #040759 and was observed welding in the 2F (horizontal) position using approved Welding Procedure Specification WPS-B-T-2132.

This QA Inspector observed Flux Cored Arc Welding (FCAW) in progress of a Complete Joint Penetration (CJP) weld joint. The Weld joint is designated SEG070A-012, Side Plate to Bottom Plate hold back weld. The welder is identified as #040367 and was observed welding in the 1G (flat) position using approved Welding Procedure

This QA Inspector observed Flux Cored Arc Welding (FCAW) in progress of a Complete Joint Penetration (CJP) weld joint. The Weld joint is designated CB3001A-017-005, Side Panel to Bottom Panel. The welder is identified as #066421 and was observed welding in the 2G (horizontal) position using approved Welding Procedure Specification WPS-B-T-32-TC-U4b-F.

This QA Inspector observed ABF personnel performing Magnetic Particle Testing on the Longitudinal Diaphragm to Bottom Plate hold back fillet weld, counter weight side at 11AW/11BW.

This QA Inspector observed back gouging of the Bottom Plate transverse CJP splice root pass.

This QA Inspector observed ABF personnel performing Ultrasonic Testing on the Side Plate transverse CJP splice, cross beam side. D scan was performed.

This QA Inspector observed ABF personnel performing Ultrasonic Testing on the Deck Plate transverse CJP splice, D scan was performed.

This QA Inspector observed the removal of fit up plates by flame cut along the Side Plate transverse CJP splice, cross beam side.

This QA Inspector observed fit up of the Bike Path Cantilever at panel point 105.
